Storm Damage Report

Memorial Inn & Suites
9535 Katy Freeway
Houston, Texas 77024

FIELD REPORT FOR INITIAL STORM DAMAGE INVESTIGATION

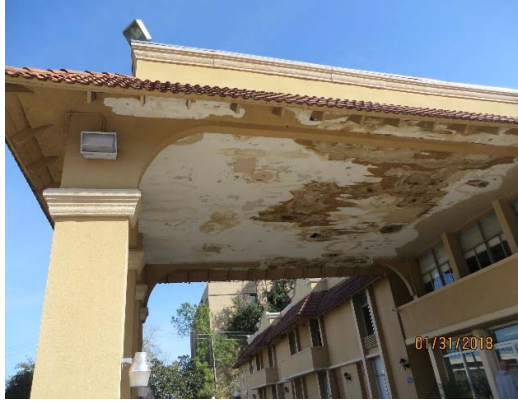
Figure 1A

- The ceiling of the porte-cochere was water damaged and the finish was removed for safety reasons.
- Many of the window air-conditioning units had damage to the plastic fins. Some were said to be broken as a result of the storm, while others were broken from unrelated causes.

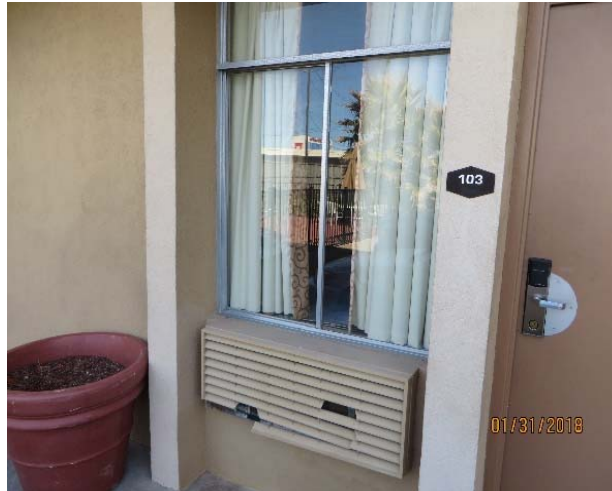
Figure 2

- Several windows were broken from wind or wind-borne debris. Units with broken windows include 104, 114, 116, 117, 124, 166, 171, 177, 184, 209, 257, 261, and 262.
- Some windows have been replaced and others have been removed, but not yet replaced.
- Gaps identified around window frames were new in appearance and were consistent with wind damage. These gaps should be considered storm created openings.

1. Follow all applicable building codes.
2. Remove all existing low-slope roofing materials down to the concrete decking.
3. Dry down concrete to roofing insulation manufacturers requirements prior to installing new roof system.
4. Install a minimum of 3" of tapered polyiso board above deck.
5. Relocate all scuppers to accommodate height change.
6. Build new parapet with parapet bracing to meet current code requirements.
Note: This will require special engineering design.
7. Replace all removed roofing materials and appurtenances with new similar materials.
8. Remove and replace all water damaged materials on the porte-cochere.
9. Repair any storm damage related interior water damage.
10. Replace all storm damaged windows.
11. Replace any storm damaged through-wall air conditioning units.

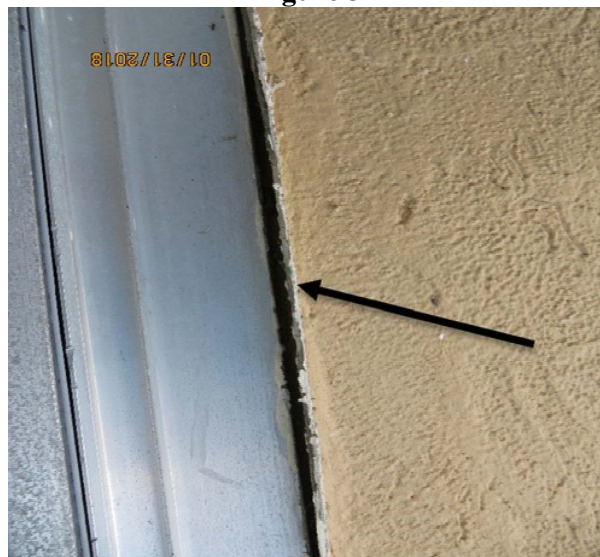
Figure 3A

- Widespread damage identified to the exterior wall finish along the bottom of walls due to standing water during the tropical storm. This was observed by FBS and confirmed by property management. Water caused the parging to separate from the CMU at a number of locations. This damage typically extended up 12" from the grade line.

In our opinion additional windows have been damaged by wind and require replacement. In our opinion, parging at the base of the structure was water damaged requiring removal and replacement. In our opinion, the scope of repairs allowed for by the carrier was deficient.

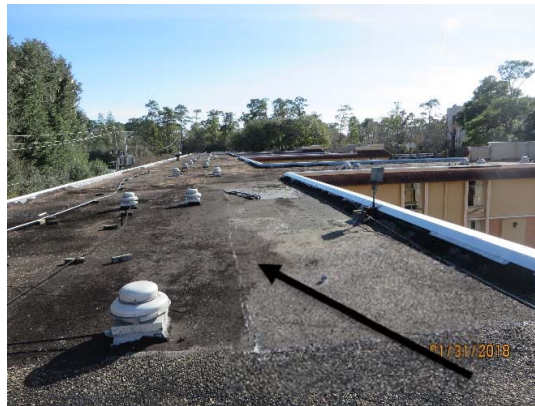
Figure 5

- Parapets are capped with metal. The interior side of the 12-inch high parapets were covered with BUR that extended up the wall and under the metal cap. The exterior side was sloped and clad with concrete tiles, except for the east elevation, which was clad with 3-tab asphalt shingles. Along the southern end of the east elevation, concrete tiles were installed with battens fastened directly through the existing 3-tab shingles.

- Scour and cap sheet separation and debonding was observed on the BUR.[See Figure 5]
- Decorative 6- foot high wood-framed parapets were installed on top of the roof above the functional parapets along the north elevation and the west ends of each wing. The interior side of these parapets were clad with plywood. The top of these parapets were clad with exterior insulation and finish system (EIFS) which was capped with metal. During our inspection, a crew was replacing plywood that had been dislodged during the storm event. In general the plywood was in poor condition.

In our opinion, removal of the roof system to the concrete deck, drying out of the deck and installation of new above deck insulation with a new roof covering will be required as a result of damage from the storm event. Parapet walls will require replacement. New roof system will not allow for any gravel ballast.

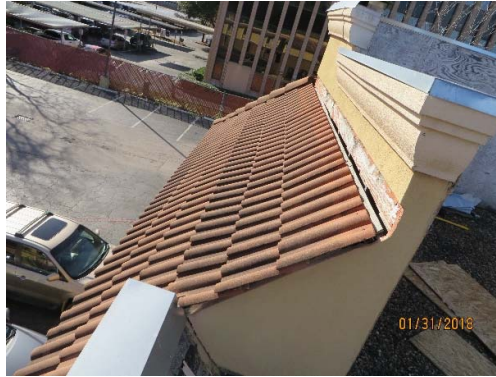
Figure 6

- 2" x 4" non-conventional wood bracing used for tall parapets.

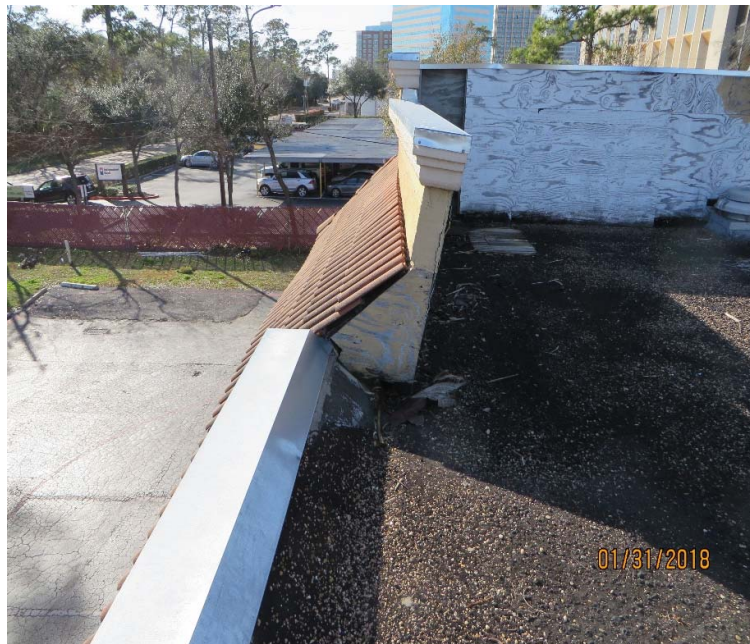
Figure 8 Parpet pushed inward

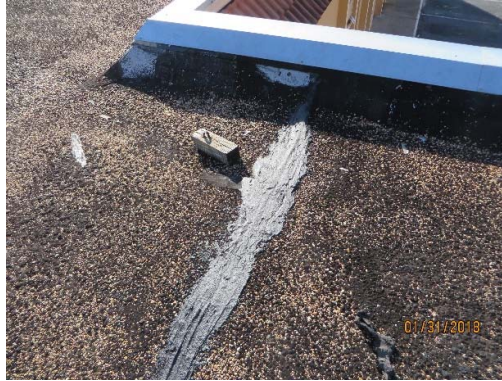
Figure 9

- Roof areas where an additional flood coat was applied
- A temporary repair with a black tarp observed between the first and second wings.

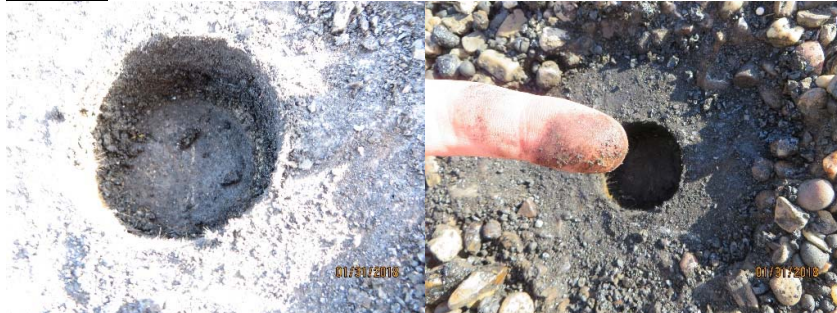
Core #1

- Located on the 1st (northernmost) wing, 13' from South wall, 50' from East wall
- Gravel Ballast

- ½" 3-ply BUR
- ½" fiberglass insulation
- Concrete deck
- All materials were wet

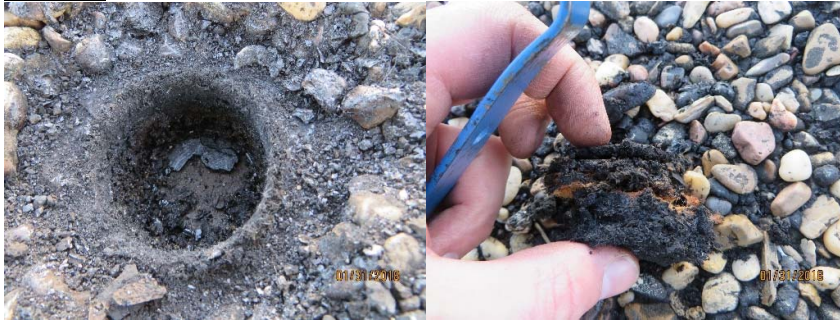
Core #2

- Located on the 3rd (middle) wing, 8' from North wall, 32' from West wall
- Gravel Ballast
- ½" 3-ply BUR
- ½" fiberglass insulation
- Concrete deck
- All materials were wet

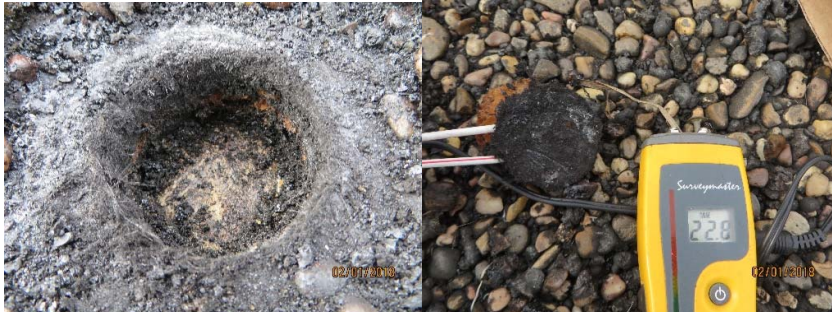
Core #3

- Located on the 5th (southernmost) wing, 7' from South wall, 8' from West wall
- Gravel Ballast
- ½" 3-ply BUR
- ½" fiberglass insulation
- Concrete deck
- All materials were wet

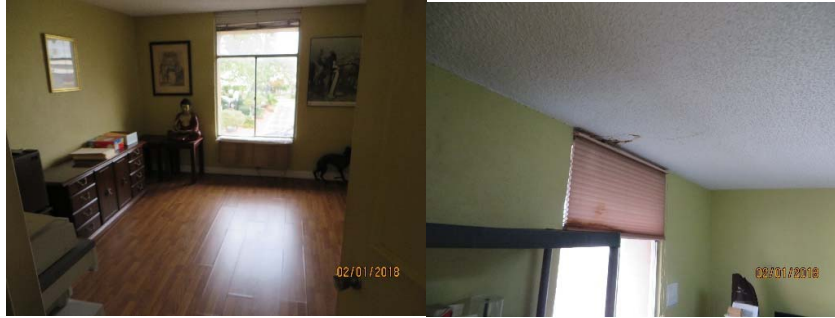
Figure 11

- Water damage to laminate floor
- Water damage to ceiling
- Water damage to window shade
- Water damage to wall
- Water damage to baseboard

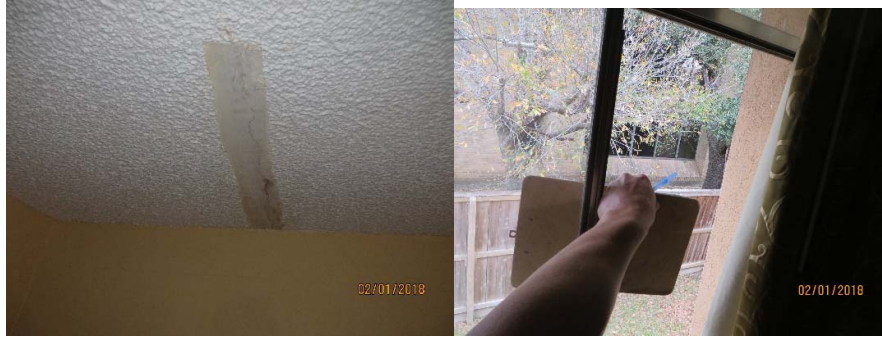
Figures 13 and 13A

- Water damage to ceiling
- Water damage to wall
- Window missing

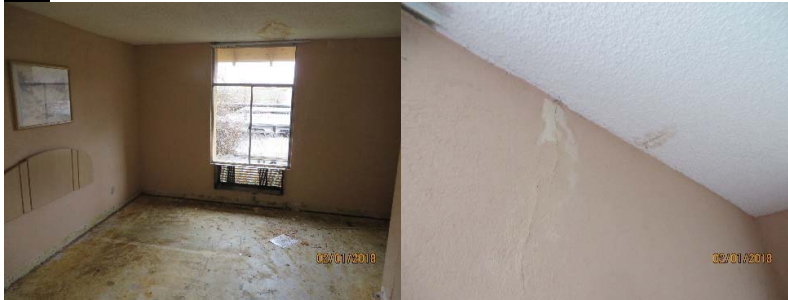
Figures 14 and 14A

- Water damage to ceiling
- Water damage to wall
- Water damage to carpet
- A/C unit missing

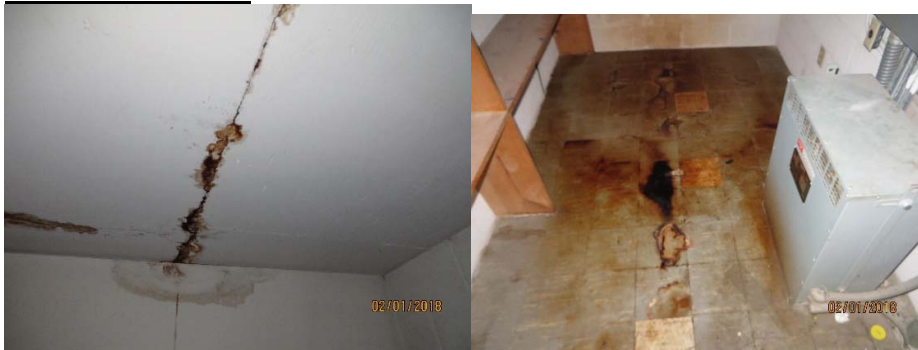
Figures 15 and 15A

- Water damage to ceiling
- Water damage to wall
- Water damage to floor

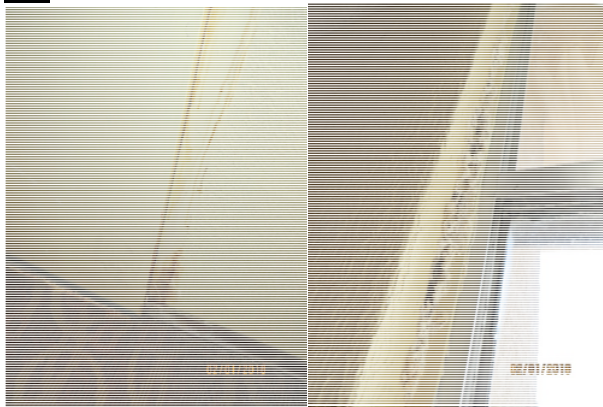
Figures 16 and 16A

- Water damage to wall

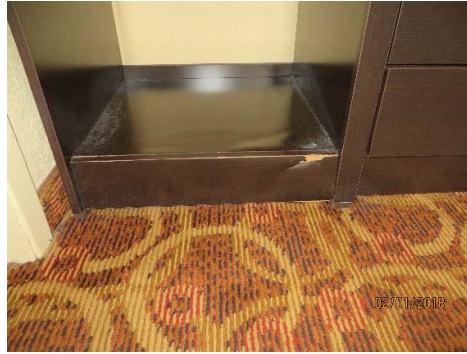
Figure 17

- Water damage to carpet
- Water damage observed on wood dresser

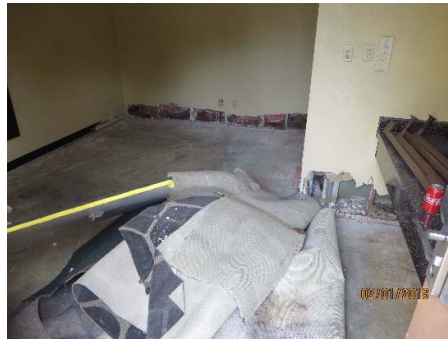
Figure 18

- Water damage to carpet
- Water damage to base of wall

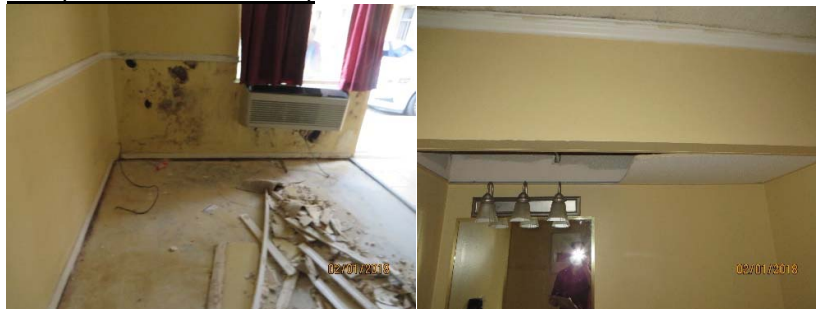
Figures 19 and 19A

- Water damage to carpet
- Water damage to wall
- Water damage to ceiling
